SiPM tester upgrade

Balazs Ujvari 04.19.2017

Fix to replaceable SiPM

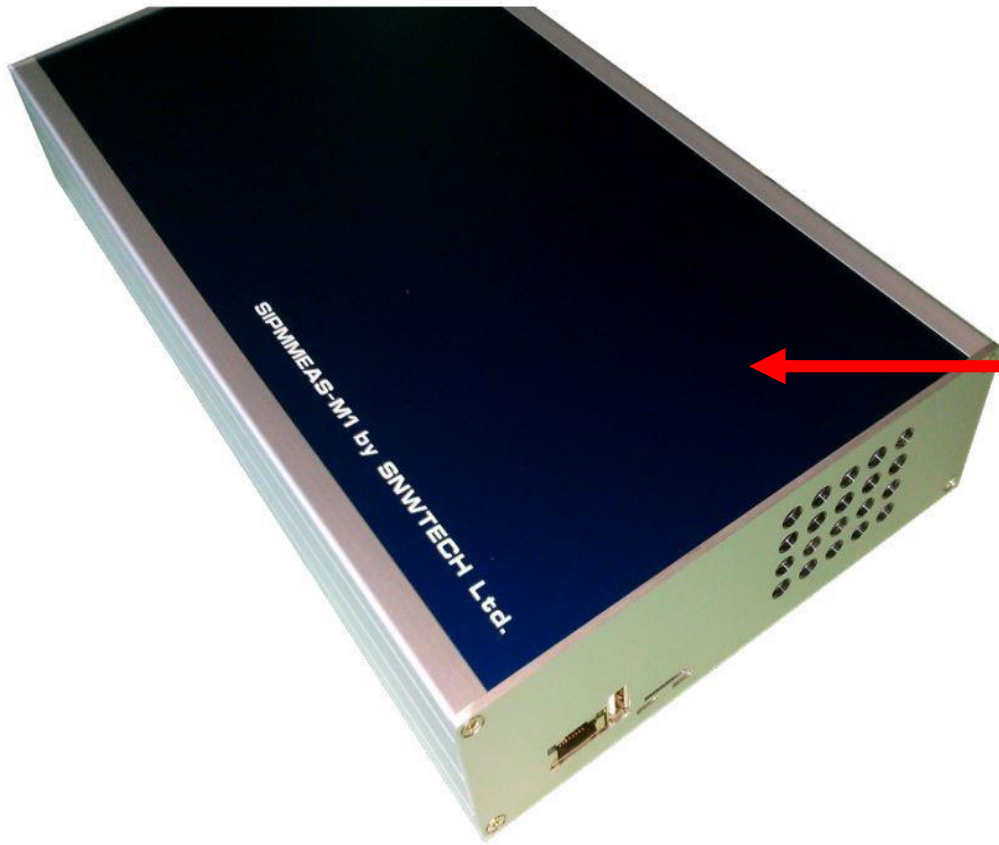
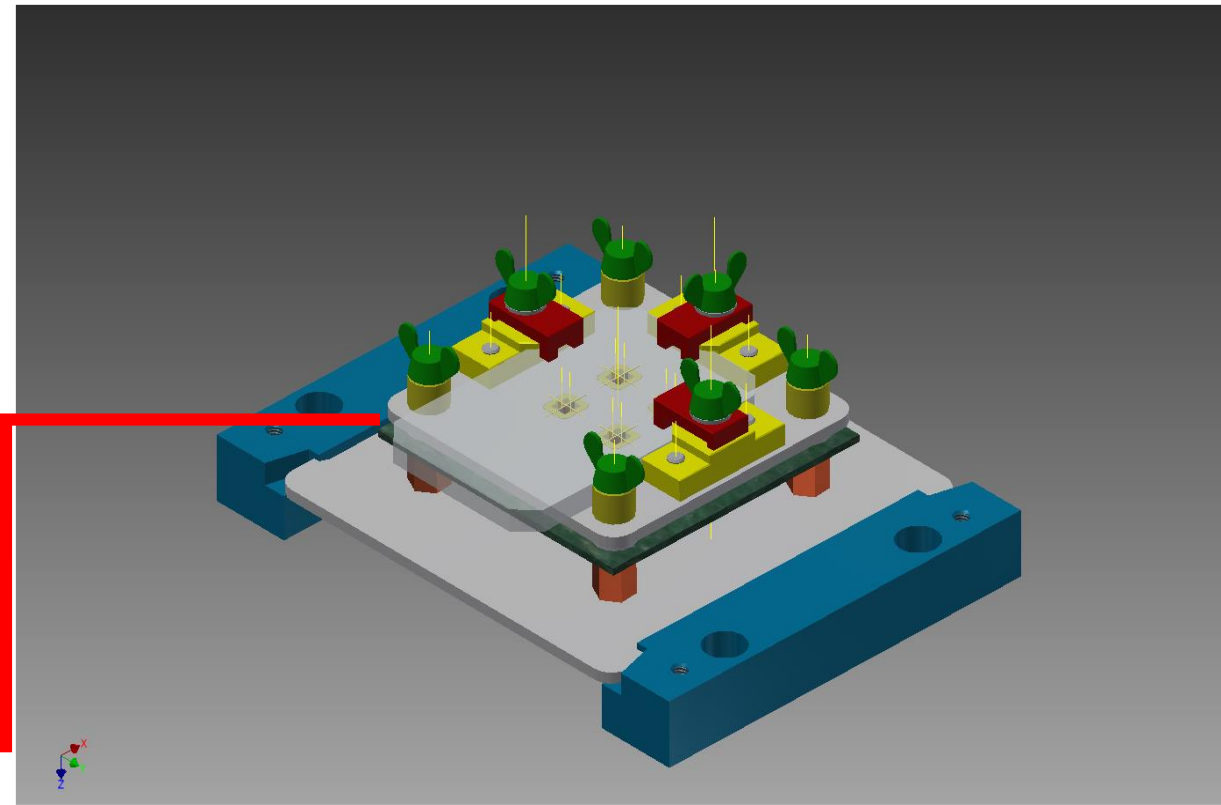
Inside

- Now the 2x2 SiPMs (fix) are on the bottom side of the black panel
- We will add a new panel, where the SiPMs will be on the top, we need to recable it, we started it.

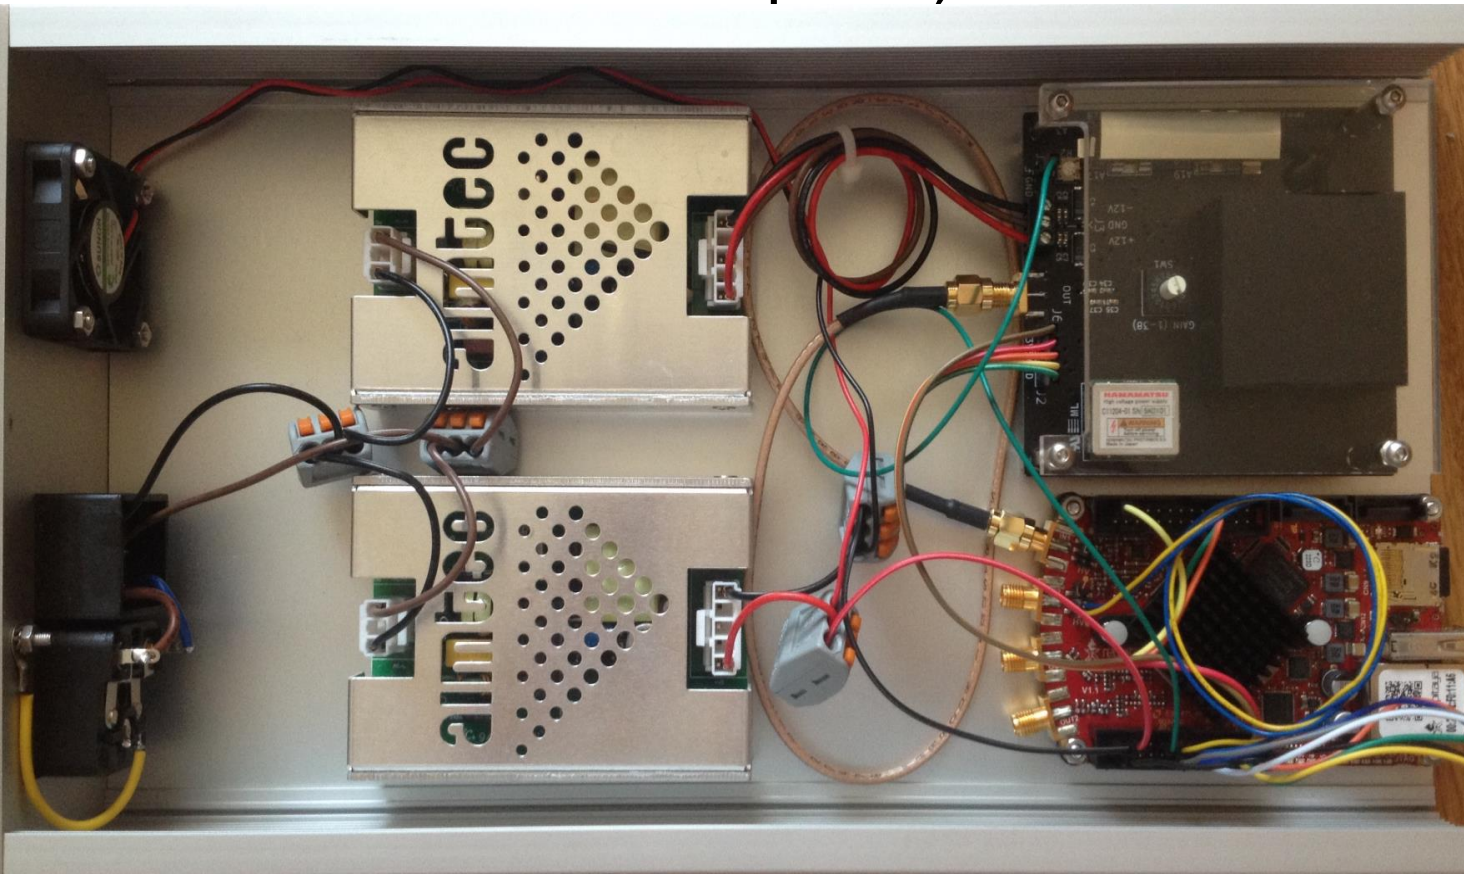
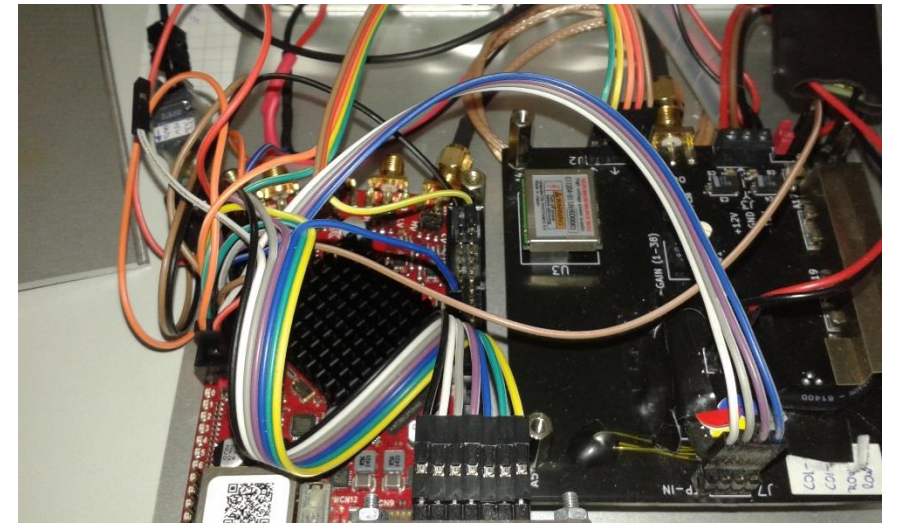
Mechanical parts on the table

We have to build this structure and modify the code
Create howto about the measurement
